## **Revised Arborist Report**

28030 Natoma Road  
Los Altos Hills, CA

**Prepared by:**  
HortScience, Inc.  
325 Ray Street  
Pleasanton CA 94566

April 2016

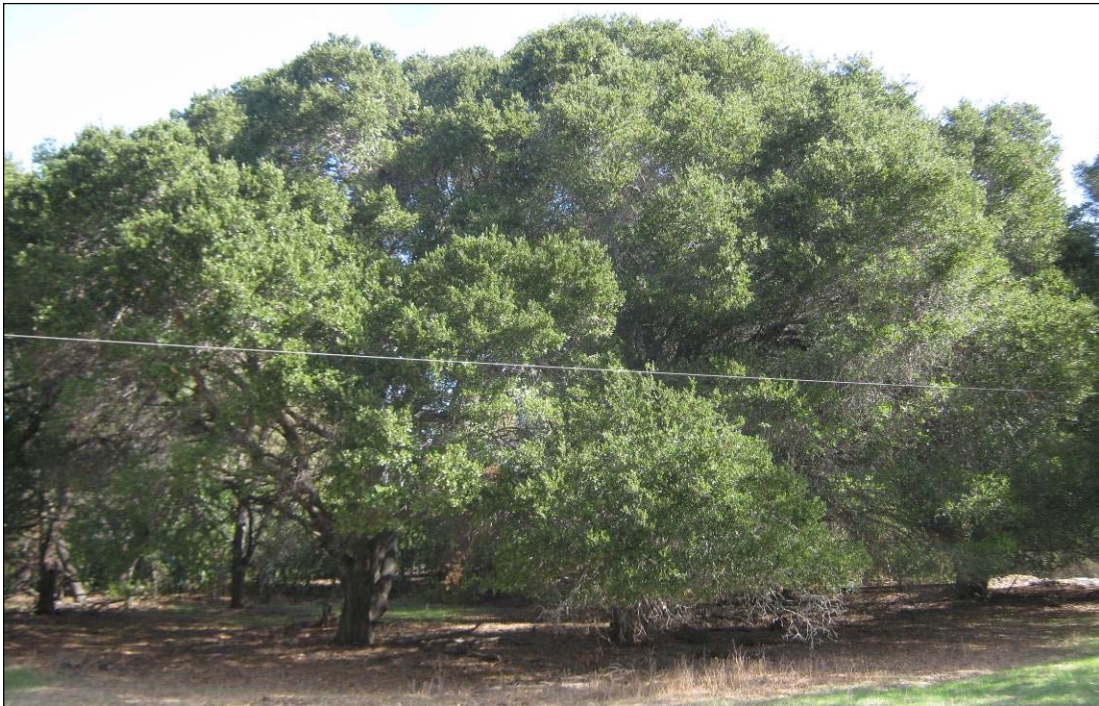
**Photo 1** (above): A group of coast live oaks near the entrance to the property (looking east). This grove was dominated by mature coast live oaks #16 and 17, with smaller-diameter trees growing at the edge of their canopies.

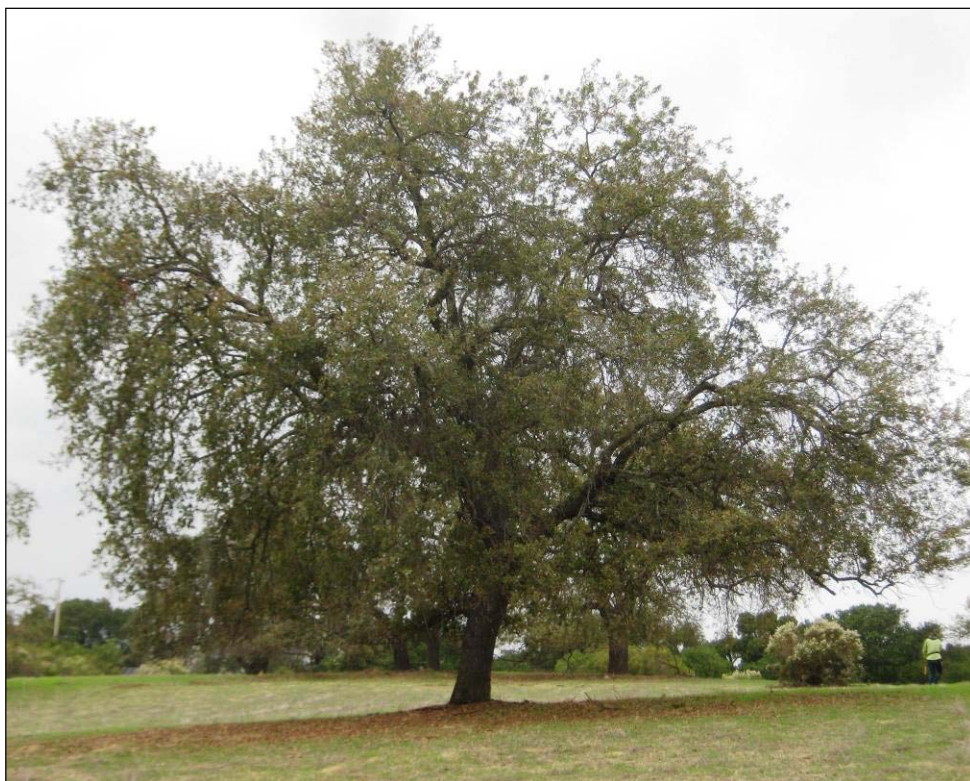
**Photo 2** (below): Open-grown valley oak #58 was growing on the northeast half of the site. The location and growing conditions were typical of the other valley oaks assessed.
