## Memorandum

Project #3863-02

**Subject: Lot 7 Drainage Assessment – 28030 Natoma Road, Los Altos Hills (Natoma Subdivision)**

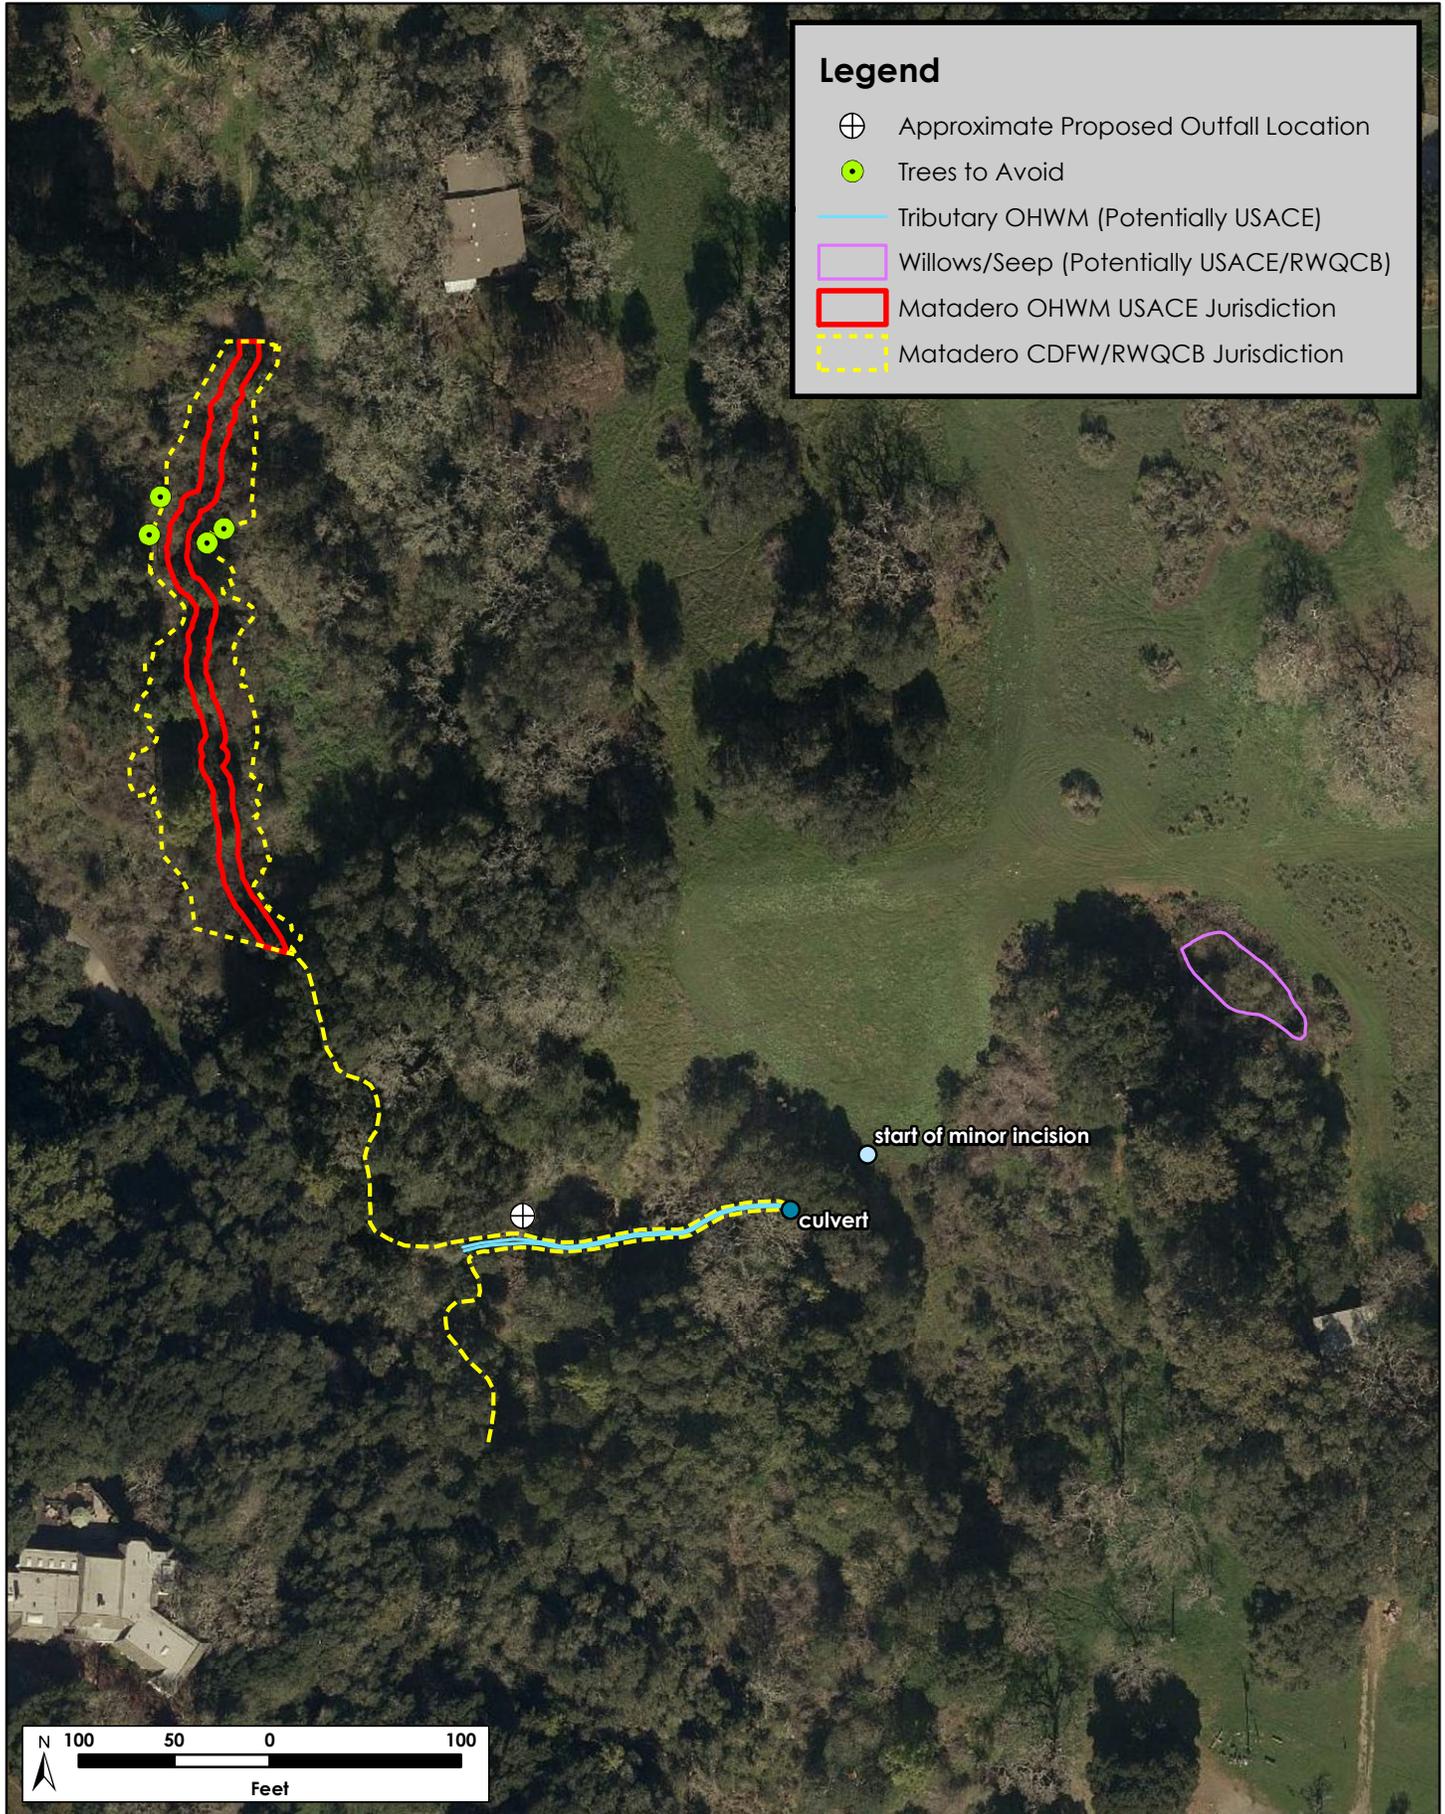
**Figure 1. Sensitive Habitats**  
 Natoma Subdivision (3863-02)  
 October 2017

There is an ephemeral drainage tributary (Figure 1, see blue OHWM lines) that originates from a 12-inch culvert outlet approximately 125 feet east of Matadero Creek. This ephemeral tributary was not mapped by the NHD, NWI, nor other agency online resources including BIOS or ECOS. The stream feature is clearly incised, with regular OHWMs indicated by shelving and changes in vegetation including exposed roots. The beginning of the drainage feature was characterized by gently-sloping banks approximately 2 feet deep with an earthen bed approximately 1 foot wide (Photo 1). As the drainage continues west towards Matadero Creek, the banks become more incised with heights of approximately 5 to 6 feet (Photo 2). At the confluence, the banks are deeply-incised at approximately 8 feet in height with an unvegetated, gravelly bed approximately 10 to 12 feet wide (Photo 3). Vegetation within the drainage, which was sparse due to scouring flows, was dominated by non-native grasses and poison oak (*Toxicodendron diversilobum*).

To the east of this tributary, uphill within the bowl, there is some slumping and erosion that does not form a clear channel, but instead appears to be a series of erosive features caused by a heavy storm event (as opposed to regular flows). The eastern, uphill limit of this area is shown on Figure 1 as “start of minor incision”. Although it is not HTH’s opinion that the feature is jurisdictional, or exhibits the indicators of regular flows between this location and the upstream terminus of the tributary at the culvert as shown on the map, there is a possibility one or more regulatory agencies would disagree and claim jurisdiction at the beginning of the erosion (i.e. at “start of minor incision” shown on Figure 1). Uphill from this location into the bowl, no indicators of incision in either a U- or V- channel form, vegetation drainage patterns, leaf litter movement consistent with streams, knick points, or sediment sorting were observed. The “bowl” area is a local topographic low point between the ridgeline to the south and the gently sloping northern rim of the bowl. Stormwater runoff will sheet flow down through the bottom of the bowl during and after storm events, but it does not do so at regular enough intervals, or at speeds or depths sufficient to create a channel or other signs of regular flows that constitute a jurisdictional drainage. No true wetland vegetation was observed in this area, though a large stand of senesced poison hemlock (*Conium maculatum*), an invasive weed which is rated as sometimes occurring in wetlands but in our experience is more of an indicator of disturbance, was noted just uphill of where the minor erosion began.

Matadero Creek is a tributary to a navigable water (the San Francisco Bay via Mayfield Slough) and it is therefore a waters of the U.S. up to the OHWMs on each bank and the lateral extent of any adjacent wetlands or associated tributaries. This equates to the low flow channel of Matadero Creek within the project site (indicated in red on Figure 1). Within Matadero Creek, as well as within the tributary, incision can be noted along the toe of the steeply sloped banks as well as at the confluence with the OHWM of the ephemeral drainage tributary (Photo 3; Figure 1). Waters of the state jurisdiction administered by RWQCB includes Matadero Creek and the ephemeral tributary channel described above up to the top of banks or to the outer edge of the riparian vegetation, whichever is greater. The CDFW jurisdiction equates to the same areas. In the case of the tributary, the drainage channel was mapped from top of bank to top of bank due to a lack of overhanging tree cover from riparian trees, though overhanging tree canopy from the Matadero Creek mainstem was mapped as riparian jurisdiction on the south side of the confluence. It is our opinion that the jurisdictional stream (“tributary”) within Lot 7 terminates at the culvert as shown on Figure 1.

- It is our opinion that a jurisdictional stream (“tributary”) occurs within the western portion of Lot 7, and that this drainage’s upstream terminus is at the culvert shown on Figure 1 and Attachment A.

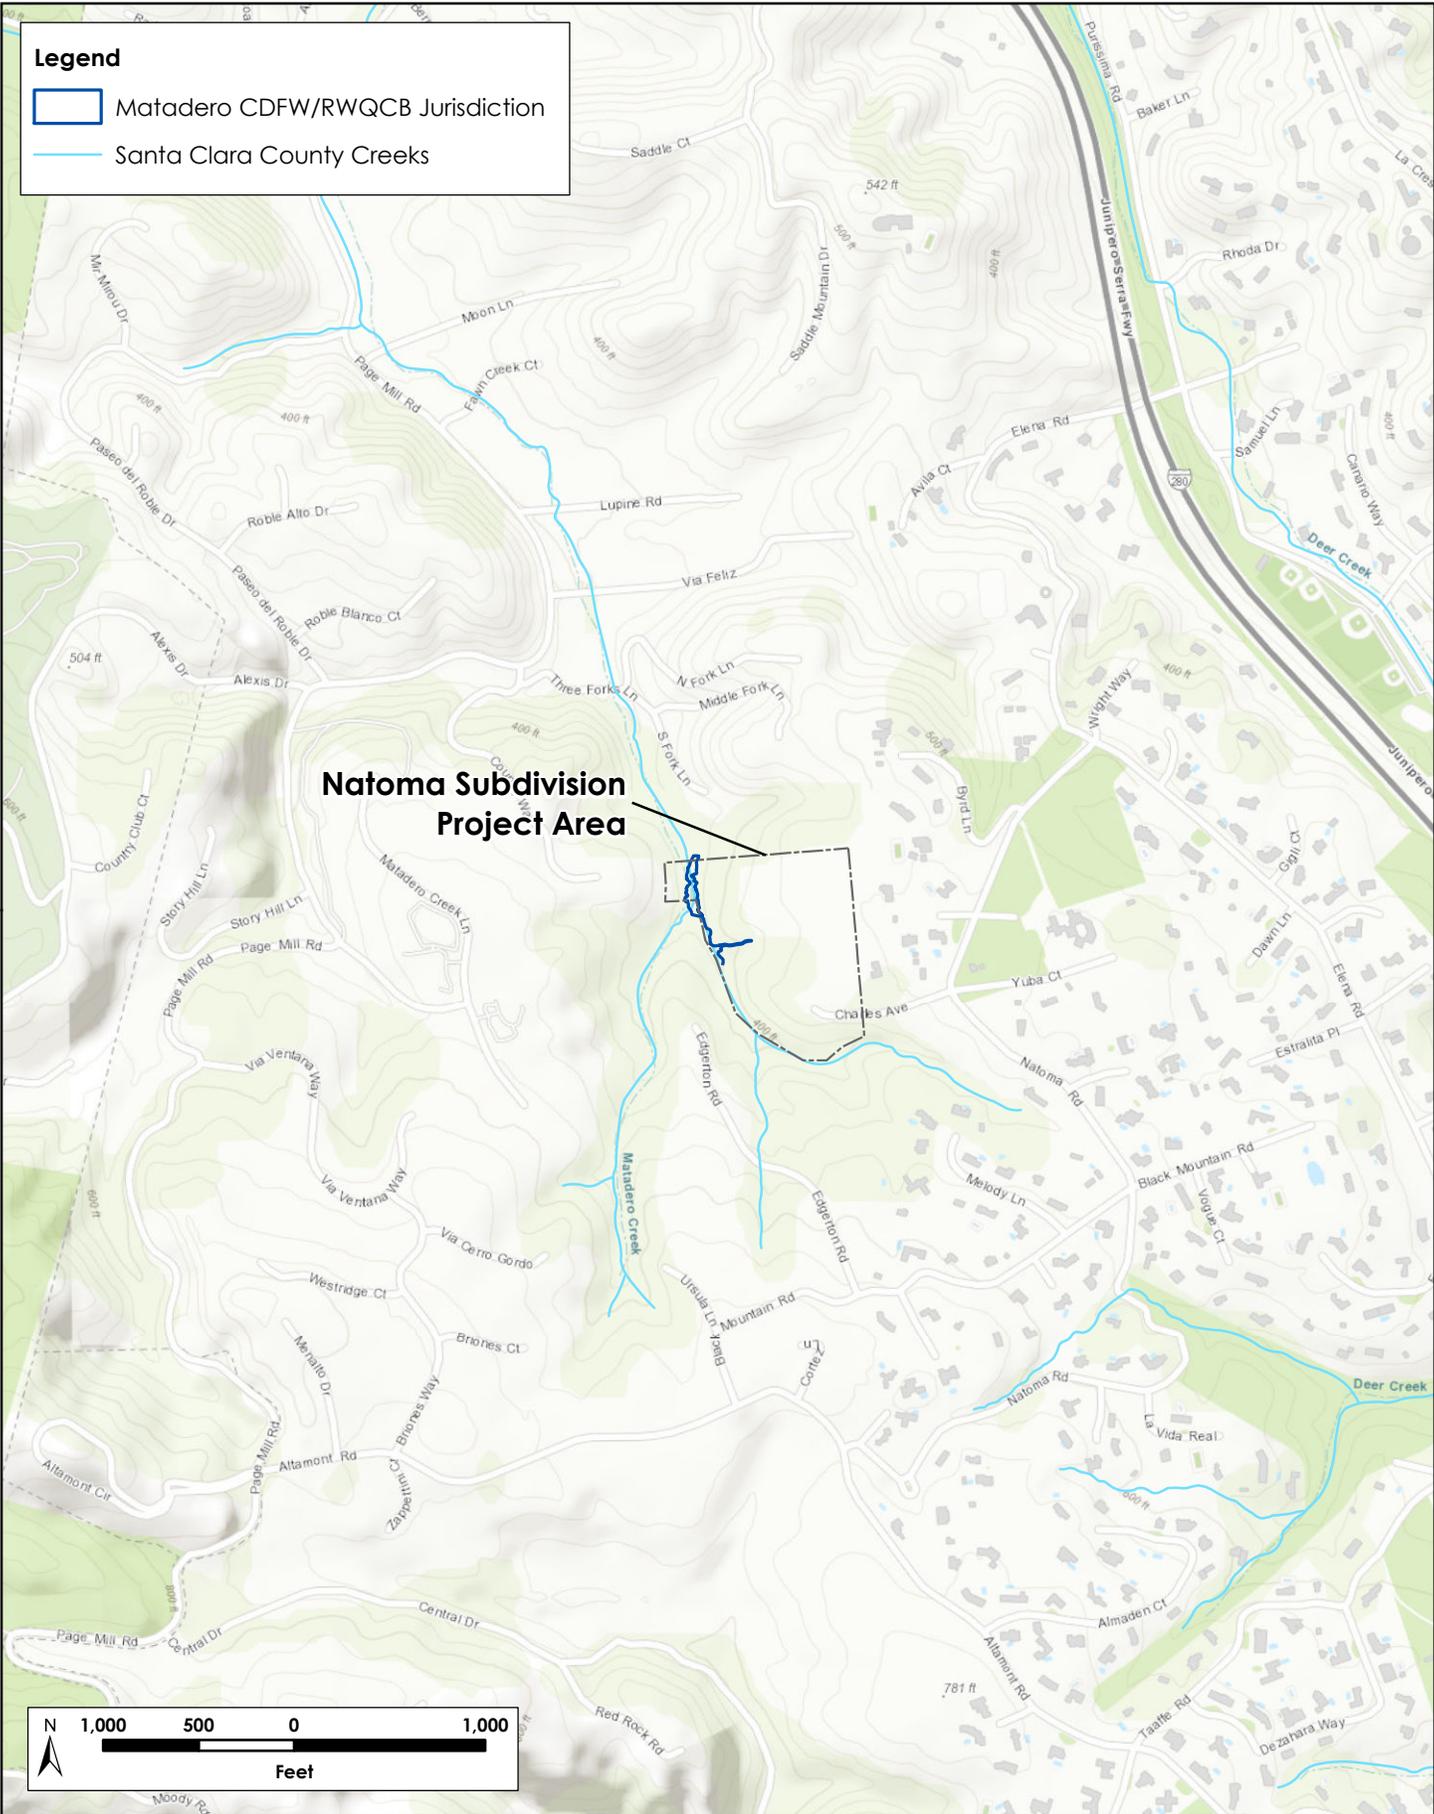
**Figure 2. Natoma Subdivision Topographic Map**

Although our background research did not indicate any previously mapped streams in Lot 7, there is an unnamed blue line stream, forming a stem of Matadero Creek, mapped by NHD (USGS 2017) and BIOS (CDFW 2017) that occurs southeast of the ephemeral drainage as shown in Figure 2, and this mapped tributary flows directly into the mainstem of Matadero Creek. This feature may be the drainage identified by the Open Space Committee during the planning commission meeting. Regardless, the small ephemeral drainage at the western end of Lot 7

that was verified in the field is not identified on any topographical map or stream database layer published for this area that HTH is aware of. We overlaid the Santa Clara County stream layer on the project design map (Figure 2, Attachment A) to determine whether this nearby unnamed tributary was within the Lot 7 area, and as shown in Attachment A, this mapped tributary does not affect development on any of the Natoma Subdivision lots. Below is a description of our jurisdictional conclusions.

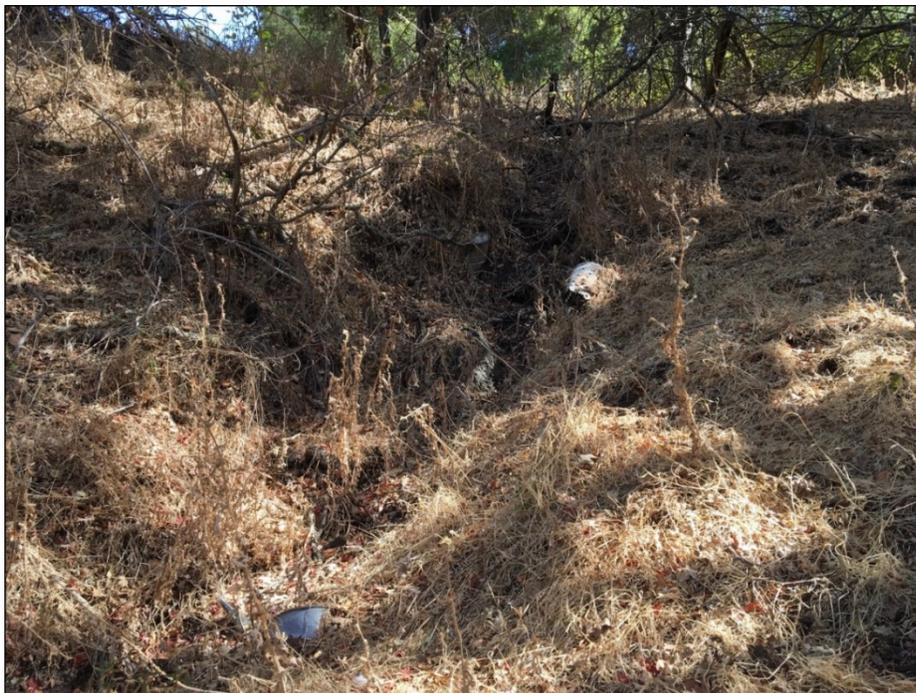
**Photo 1.** Beginning of the ephemeral drainage just downslope of the culvert outlet. Note the gently-sloping banks and incision from past flow events. The bed is approximately 1 foot wide.

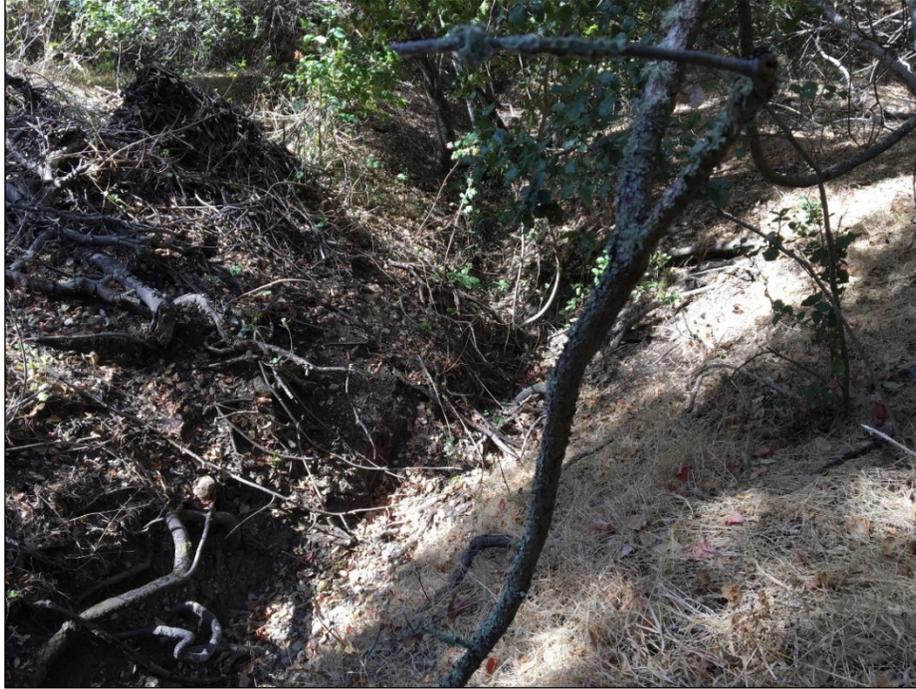
Photo 2. Midsection of the ephemeral drainage, about 50 feet downstream of the culvert. Note the steeper banks, exposed roots, and incision from past flow events. The bed is still approximately 1 foot wide.

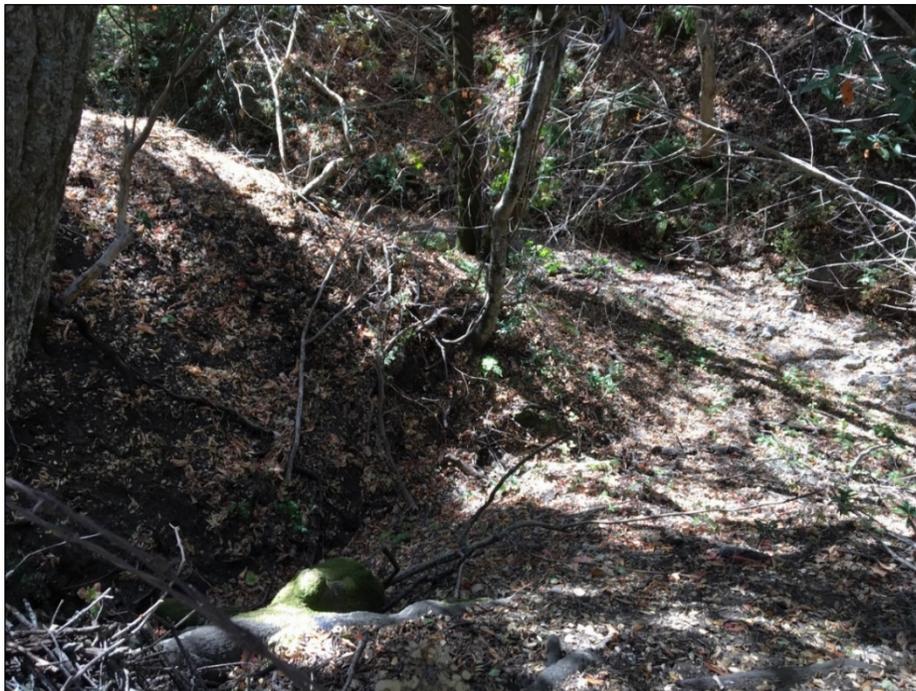
Photo 3. The confluence of the ephemeral tributary with Matadero Creek. Note the deeply-cut banks and incised channel with exposed tree roots. The bed is approximately 8 feet wide.

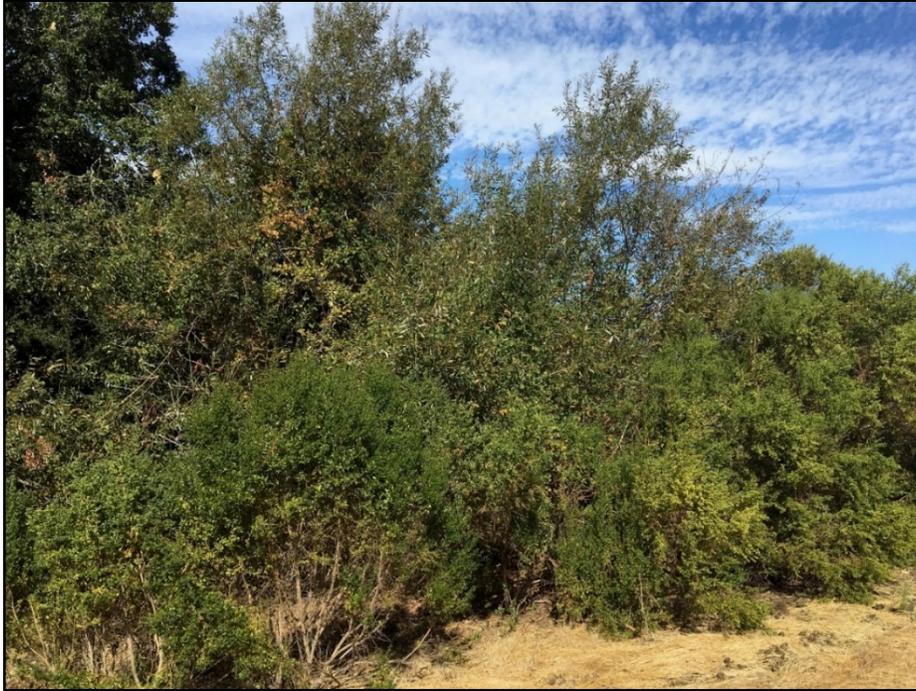
With regards to adjacent wetlands, no wetland vegetation was observed within or adjacent to the banks of the drainage during the field survey. However, a potential wetland seep dominated by red willow was detected near the top of the ridgeline and bowl approximately 300 feet east of the culvert and upstream terminus of the tributary in a nearly flat grassy section of the hillside crest (Photo 4; Figure 1). This stand is a mature-to-decadent, well established thicket. There are no associated bed and banks within the thicket, or any indicators of incision or regular flows. Typically, features such as this are fed by groundwater upwellings, and there were indicators of hydric soils within the thicket that could indicate such a source of hydrology for this stand (Figure 1, purple), although the hydric soils did not extend to the outer edges of willow canopy. Jurisdictional wetlands only occur where wetland vegetation, hydric soils, and active wetland hydrology co-occur.

**Photo 4.** Location of the willow-dominated potential seep near the top of the ridgeline and bowl adjacent to the proposed Lot 7 driveway. The willow thicket is comprised of mature willow trees and surrounded by upland vegetation.

- To avoid permitting requirements associated with impacting these potential waters of the U.S./state and adjacent wetlands, the applicant shall commit to siting the outfall outside the banks of the tributary drainage, in a location and with a design that will prevent erosion to the nearby banks, as well as moving the proposed driveway further east to avoid the willow-dominated potential seep.

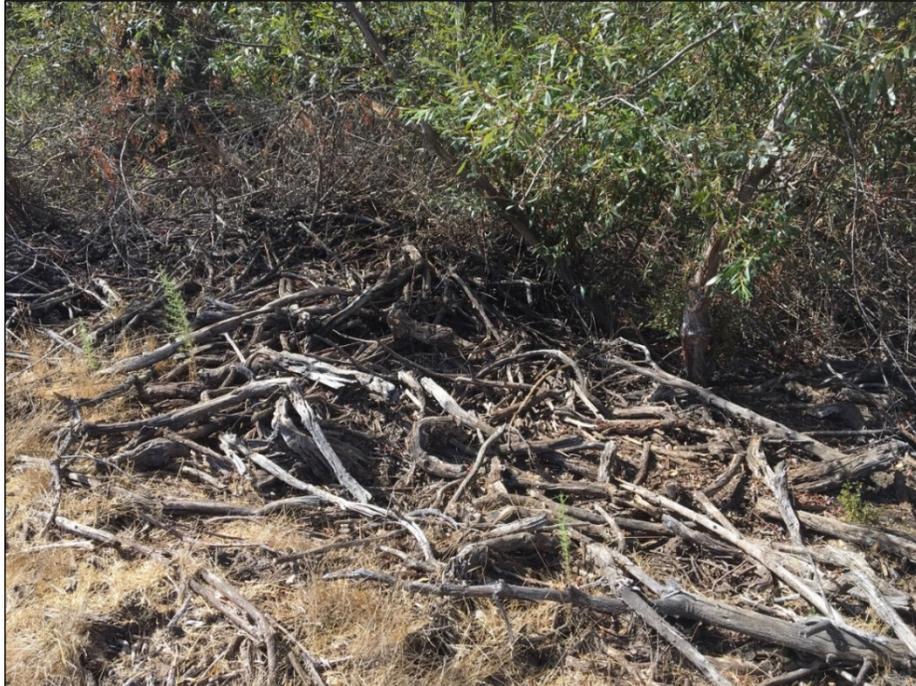
The stand of willows appears to be on the decline as several piles of dead branches and debris were noted on the outer edges of the seep (Photo 5), and no young willow saplings are germinating in the thicket. The area appeared to have been piped at one point, with a pump house and tanks located a short distance down the hill from this thicket. A soil investigation noted redoximorphic features in the upper 12 inches of the soil profile indicating the presence of hydric soils (Photo 6); however, evidence of prolonged inundation (i.e., wetland hydrology) was not observed. There was no indication of differential soil moisture within the thicket compared to the surrounding uplands. Willows can exist as phreatophytes outside of wetland conditions, which means that they can grow deep roots to access soil moisture well below the normal 2 foot rooting depth, and can therefore persist in an area where the surface does not have wetland hydrology.

**Photo 5.** Dead tree debris along the edge of the willow thicket and potential seep located near the top of the ridgeline near Lot 7. These are willow branches and are evidence of a mature, aging stand, and may also be evidence of less water within the thicket area over time.

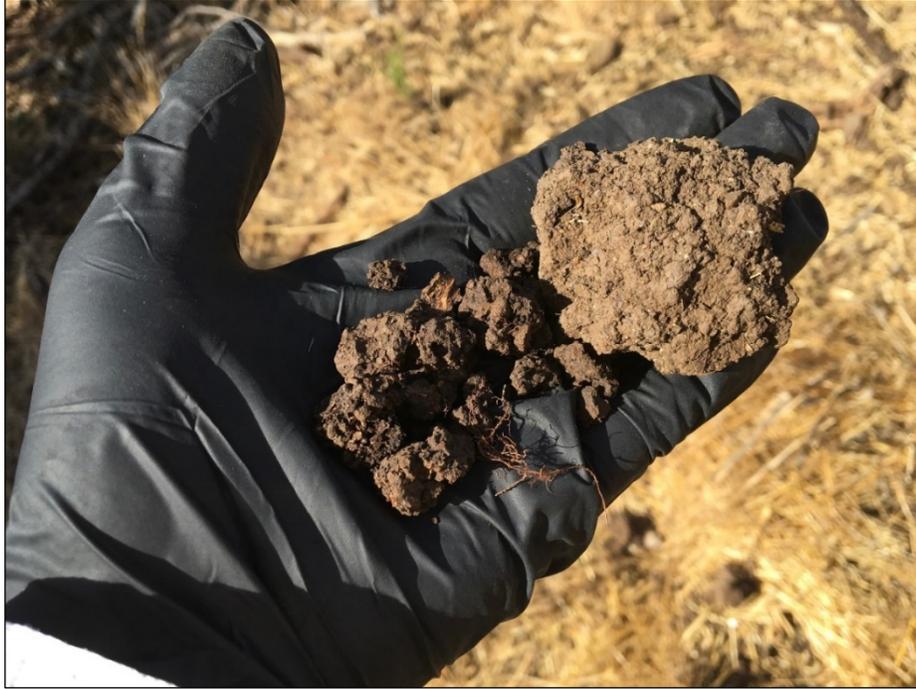
**Photo 6.** Soil sample from the willow-dominated, potentially active seep with evidence of hydric soil indicators including low chroma soils and redoximorphic features located near the top of the ridgeline adjacent to the proposed Lot 7 driveway.

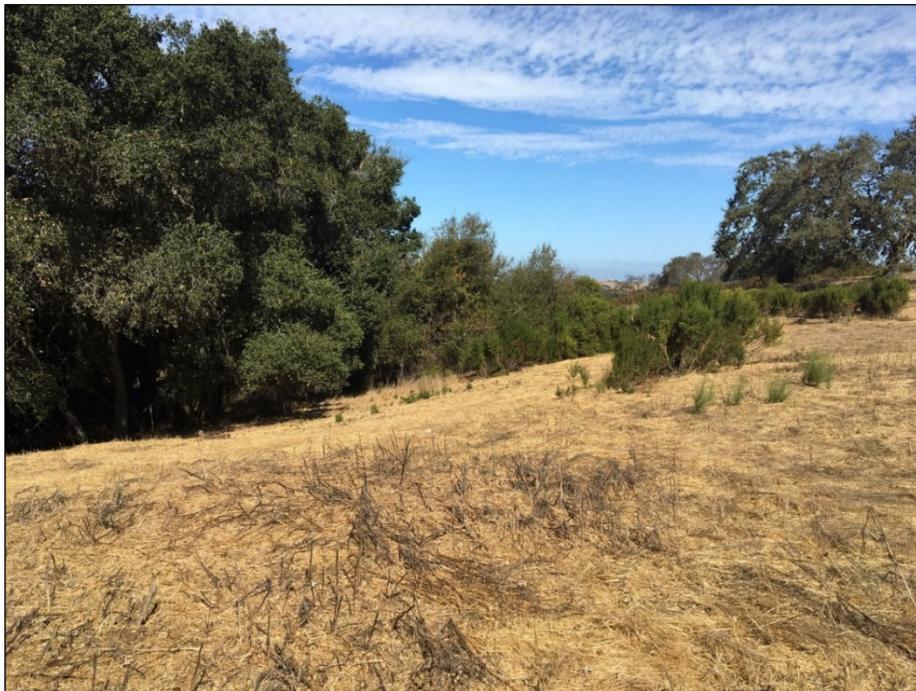
**Photo 7.** Location of willow thicket near the top of the ridgeline.
